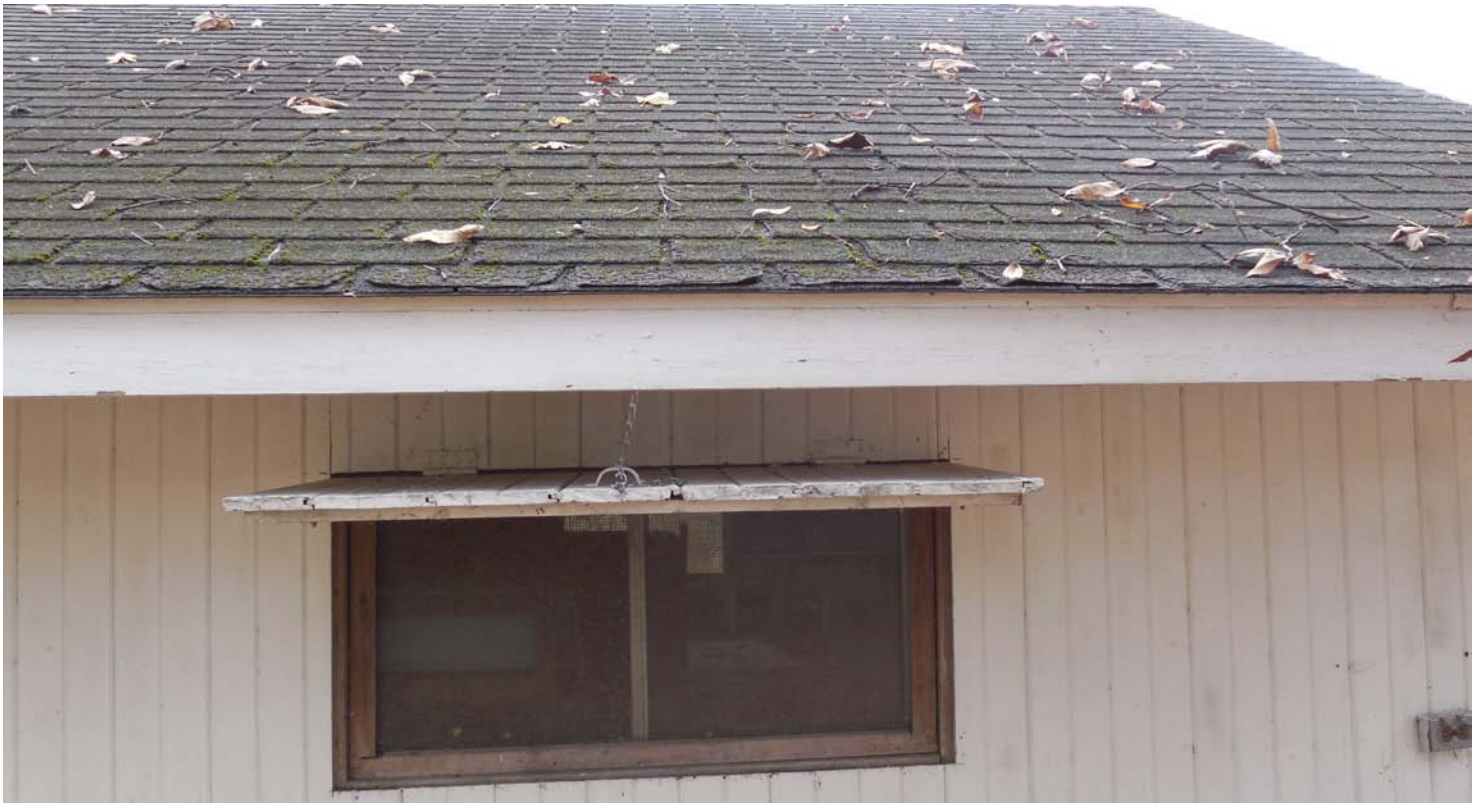
The shingles are beginning to curl and the roof will need replacing in the next couple of years. The insurance company has noted on the policy that it is in need of replacing, which means they will not pay for any damaged due to weather, etc.

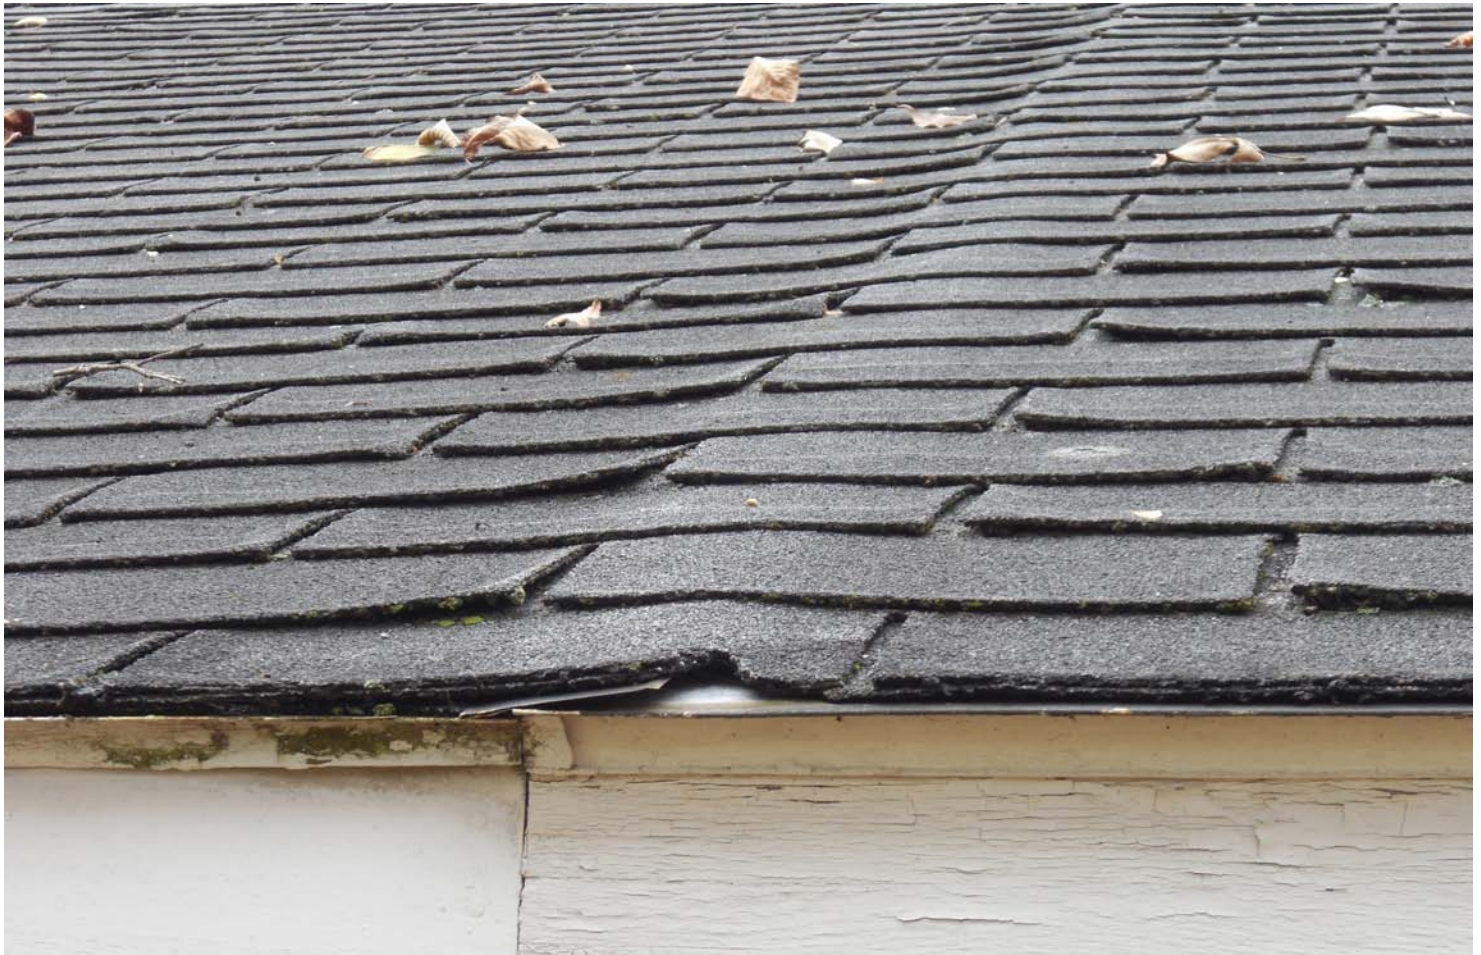
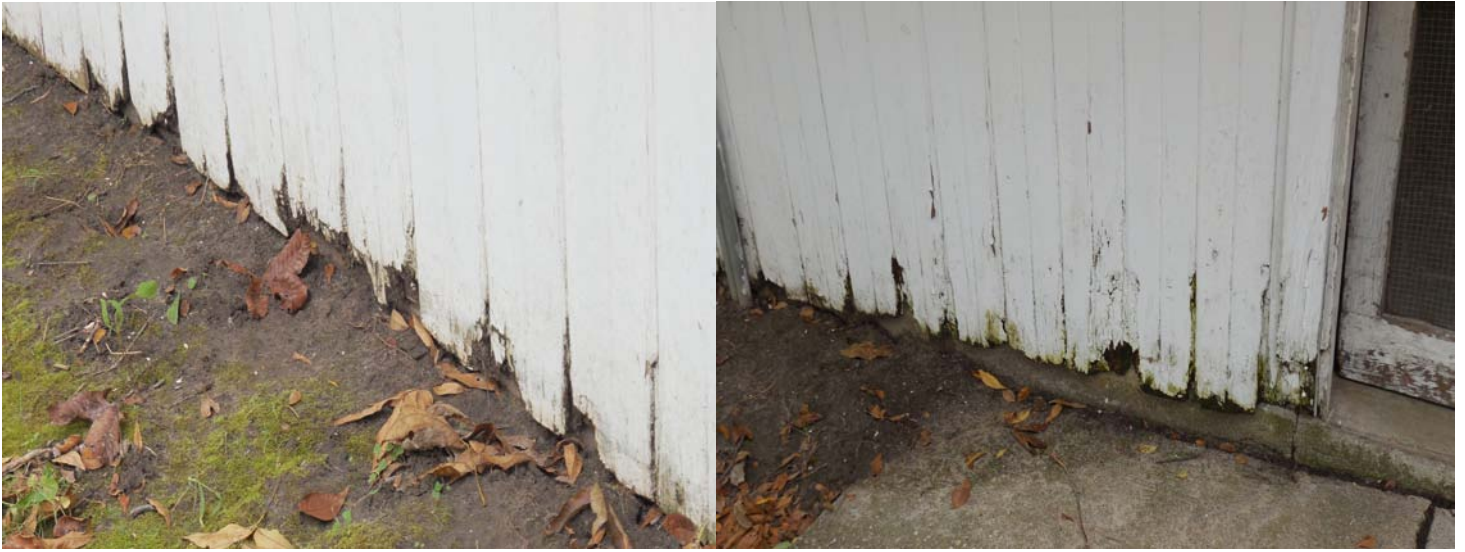
The siding is deteriorating at the bottom around most of the dorm. It is in need of painting on the south and east sides. The repair for the siding would be installing steel siding over the existing wood siding.

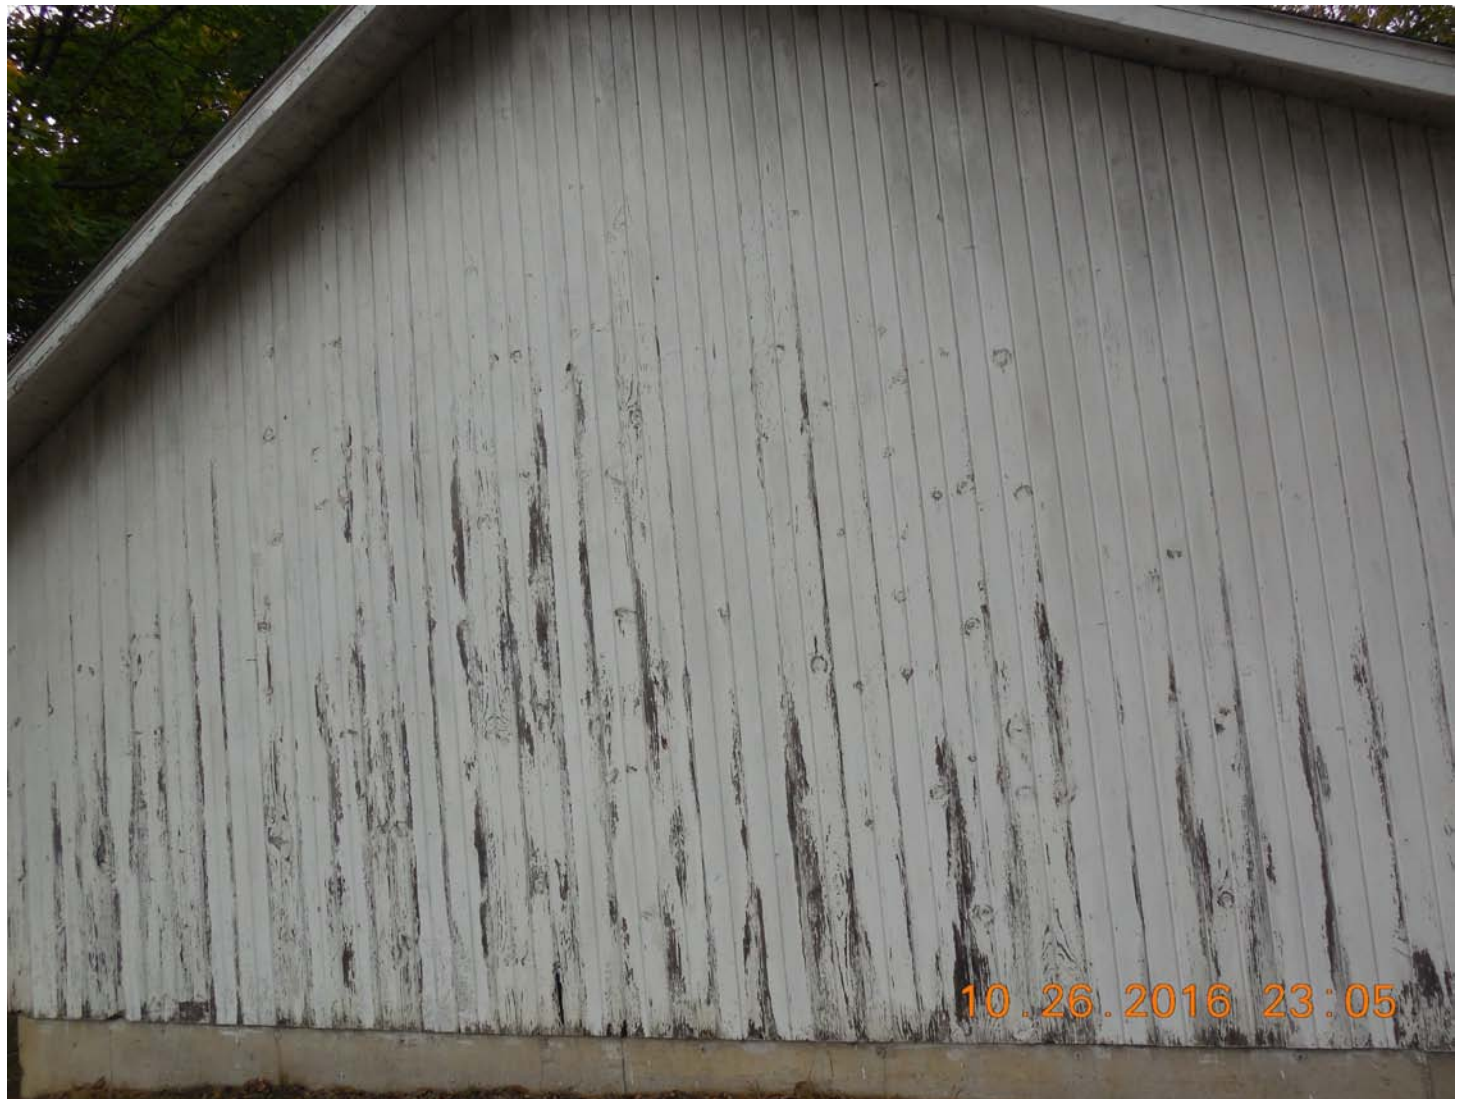
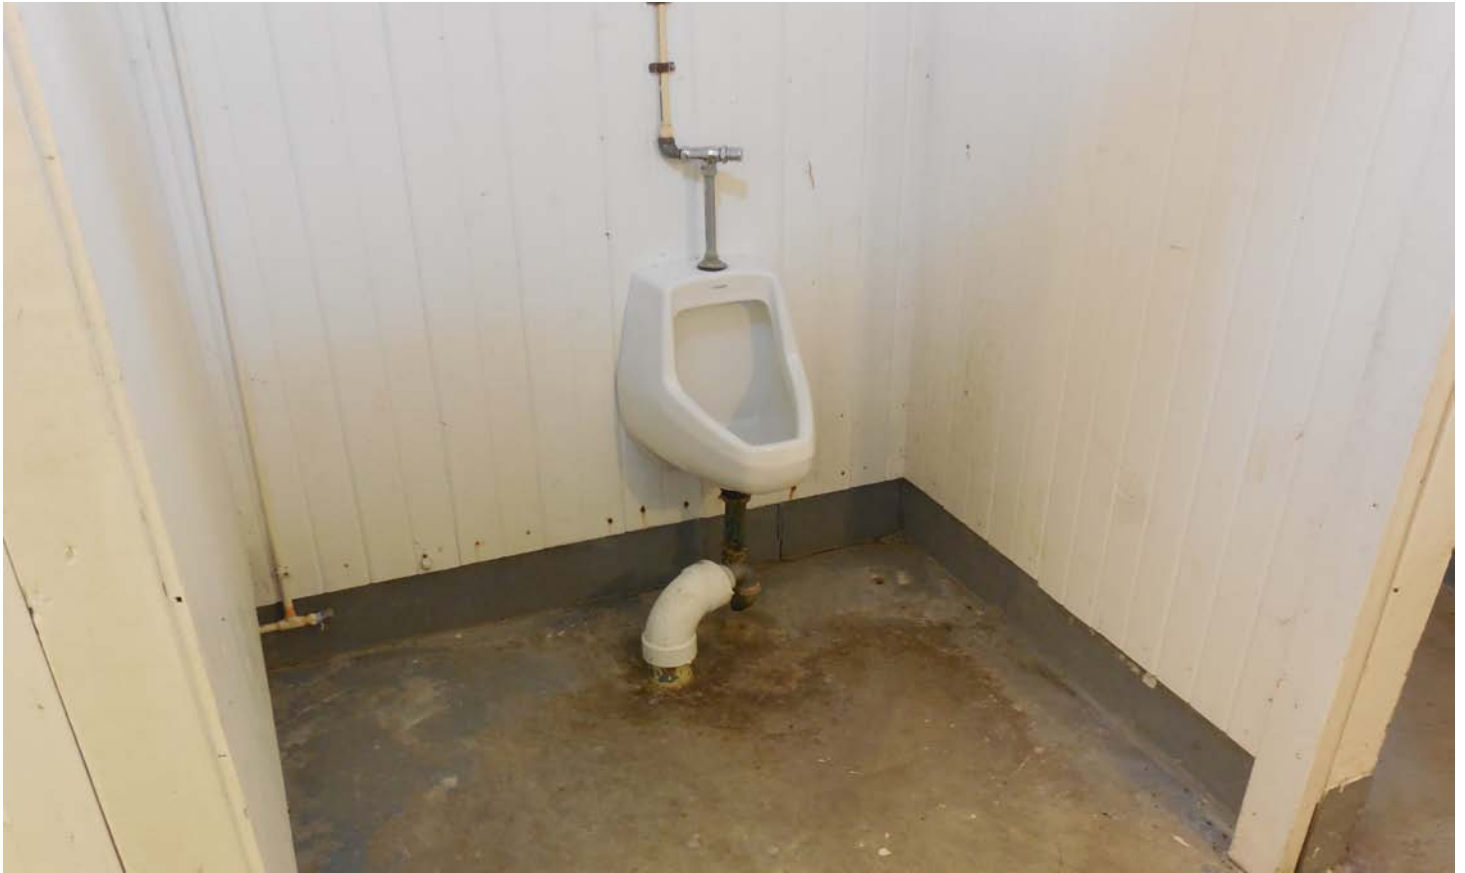
The bathroom facilities are in need of remodeling and upgrading. The boy's dorm does have ADA toilet and shower, but the current girl's dorm does not. The wooden stalls are subject to mold and mildew formation.

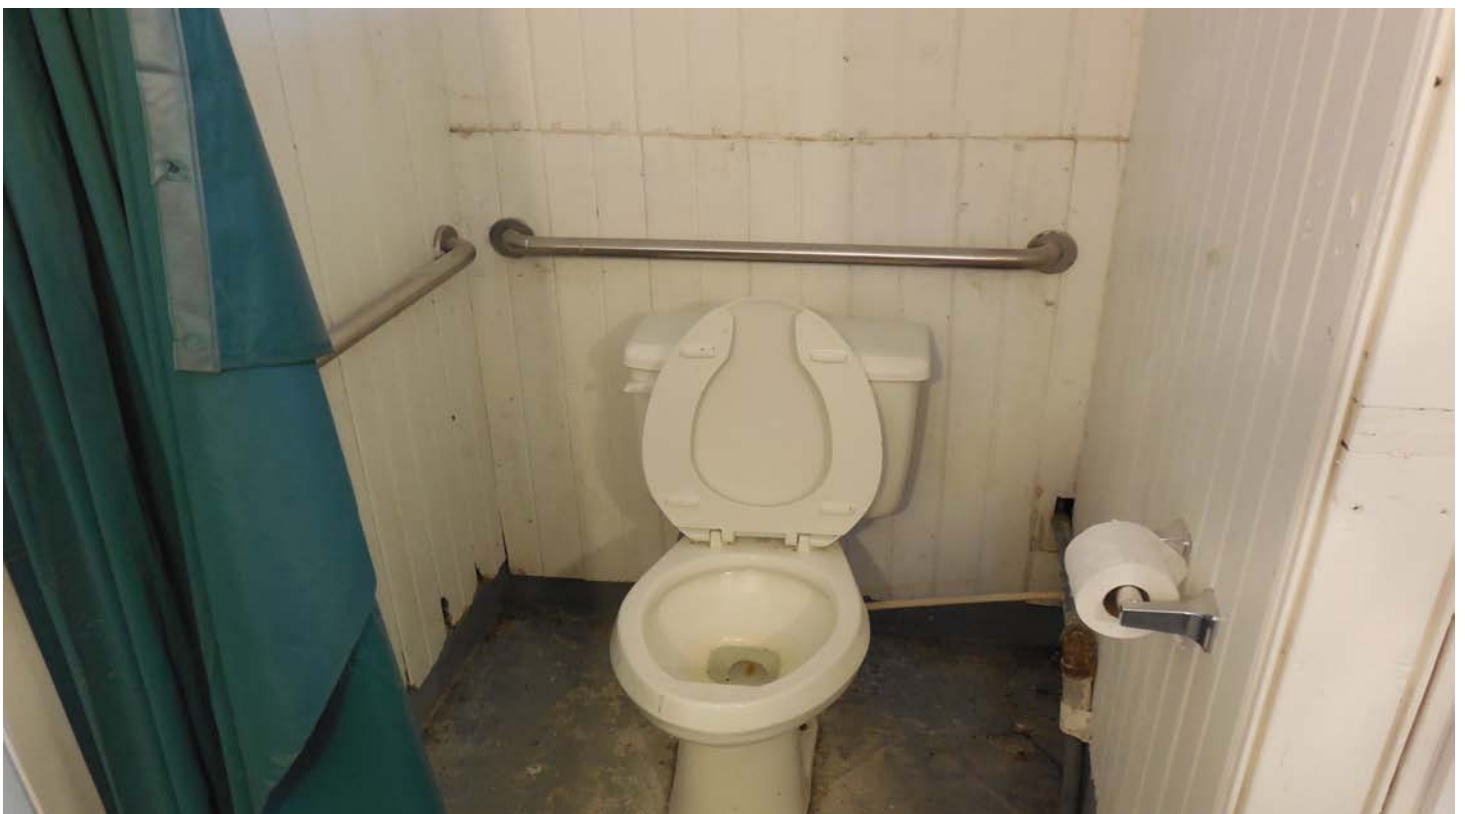
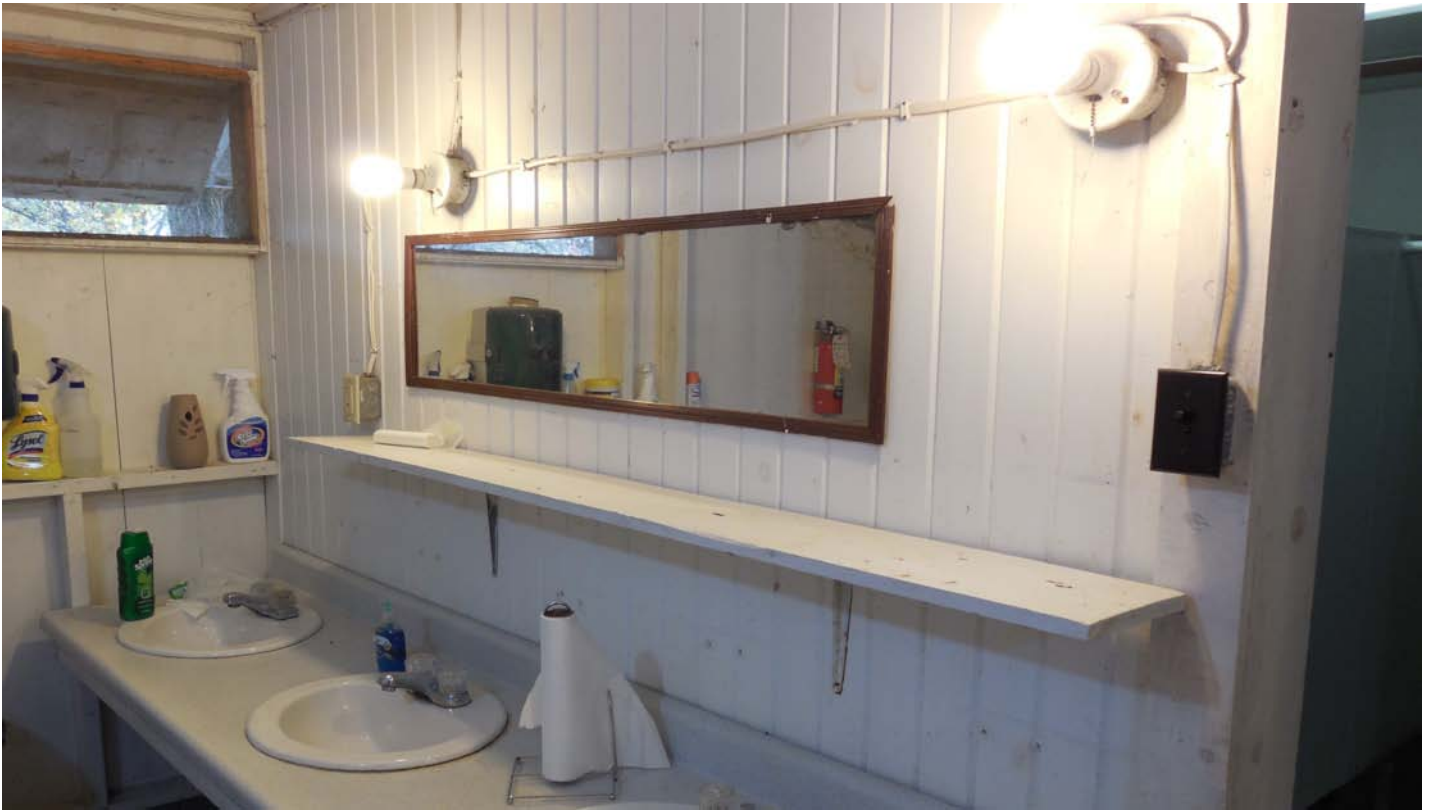
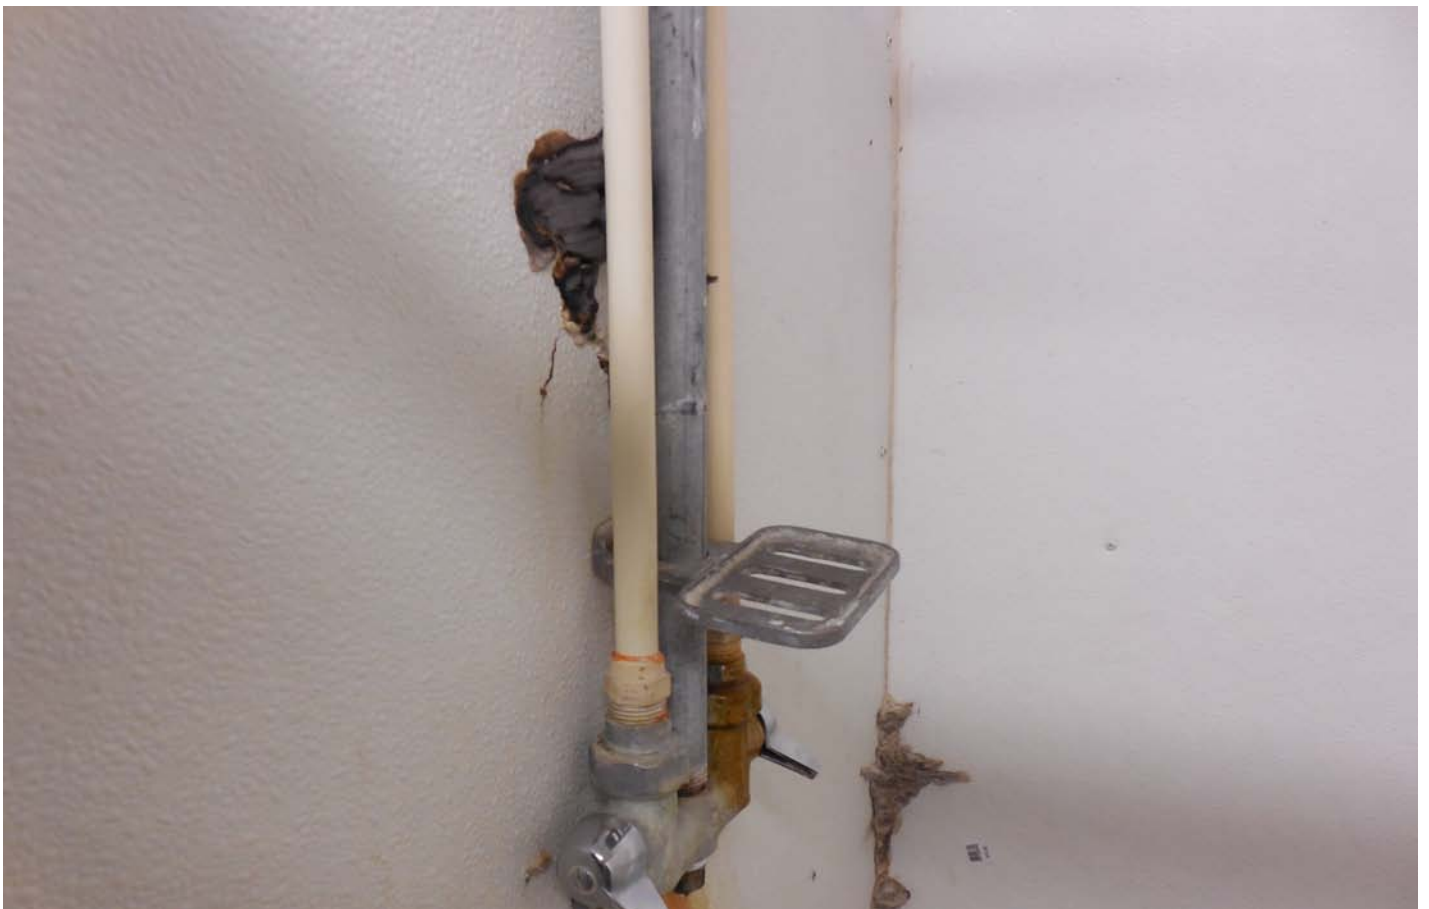
The sink area on the north side of bathroom. The shower stalls are particle board and they are deteriorating. Below is a fungus that has grown since camp ended.

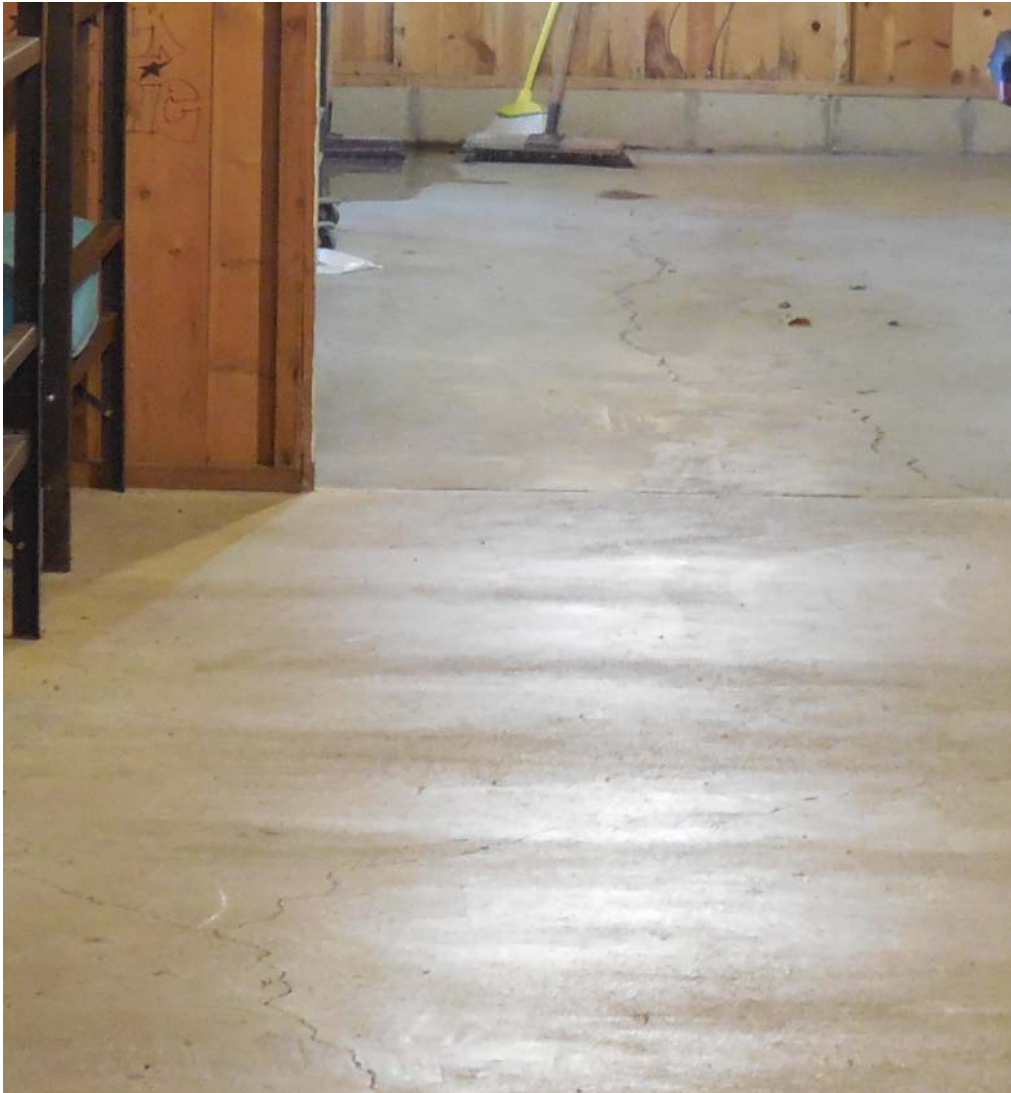
(Top picture viewed from old section of dorm looking into newer section.)

The foundation is cracked in both sections of the dorm (the one built in 1963 and the one built in 1977).

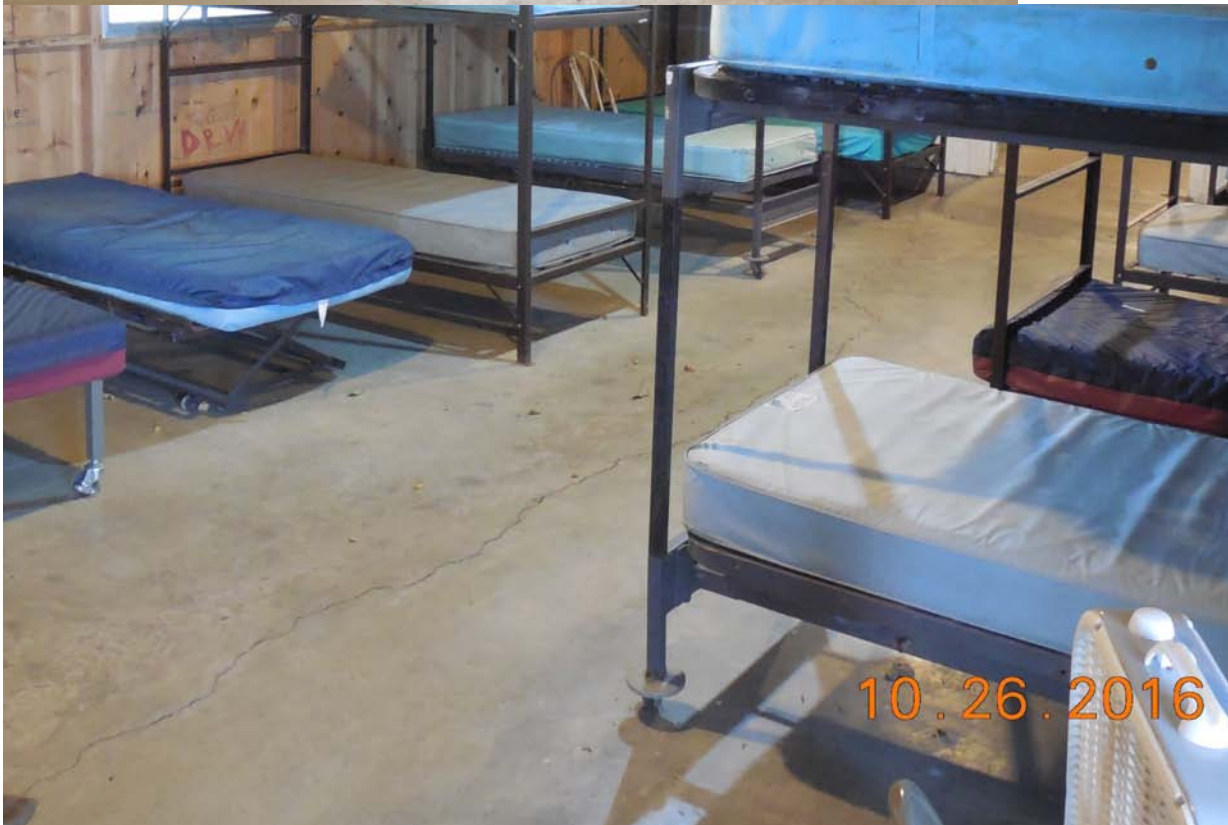
(Bottom picture in newer section of dorm)

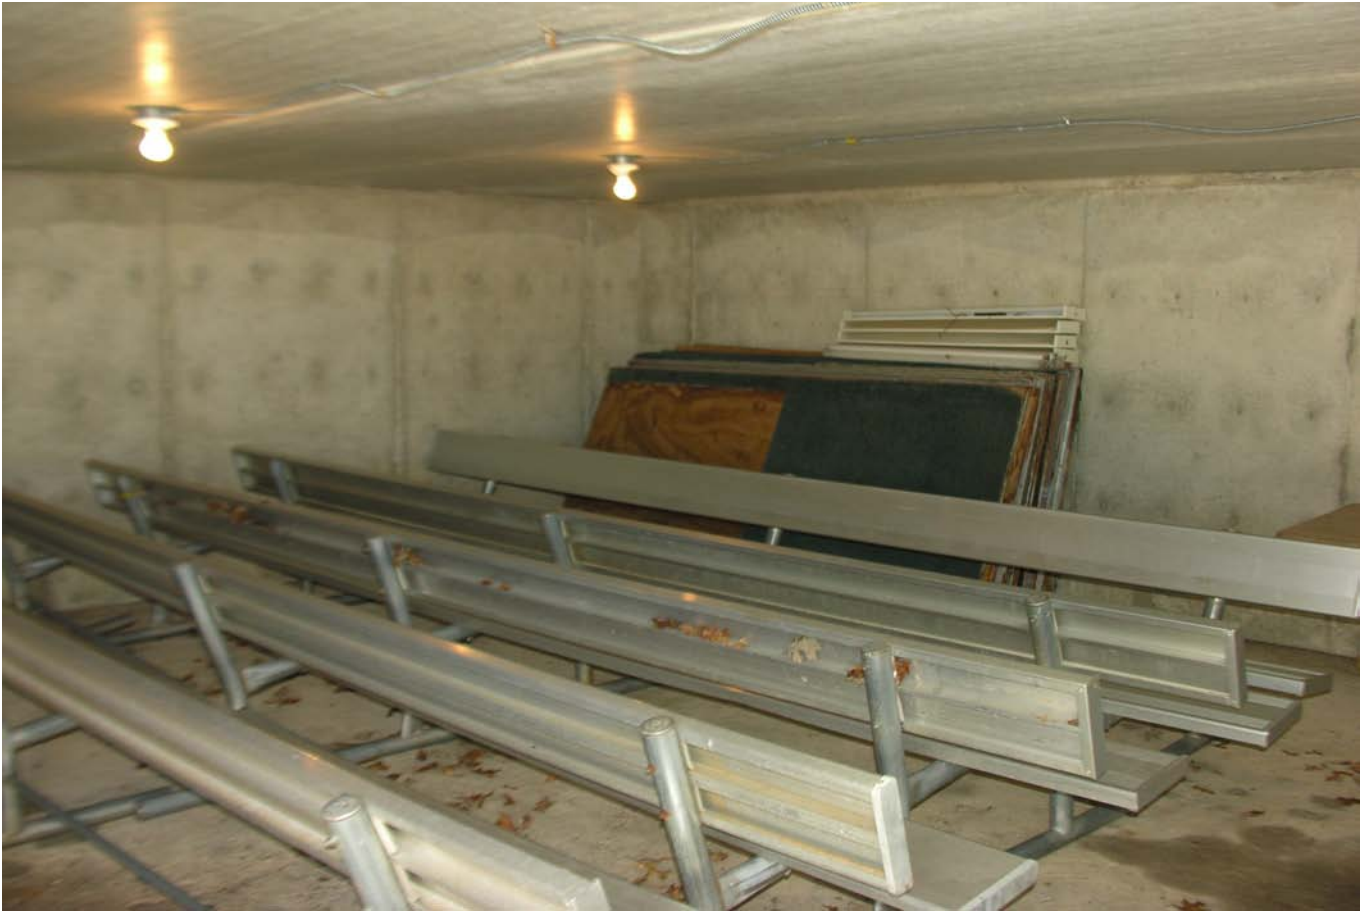
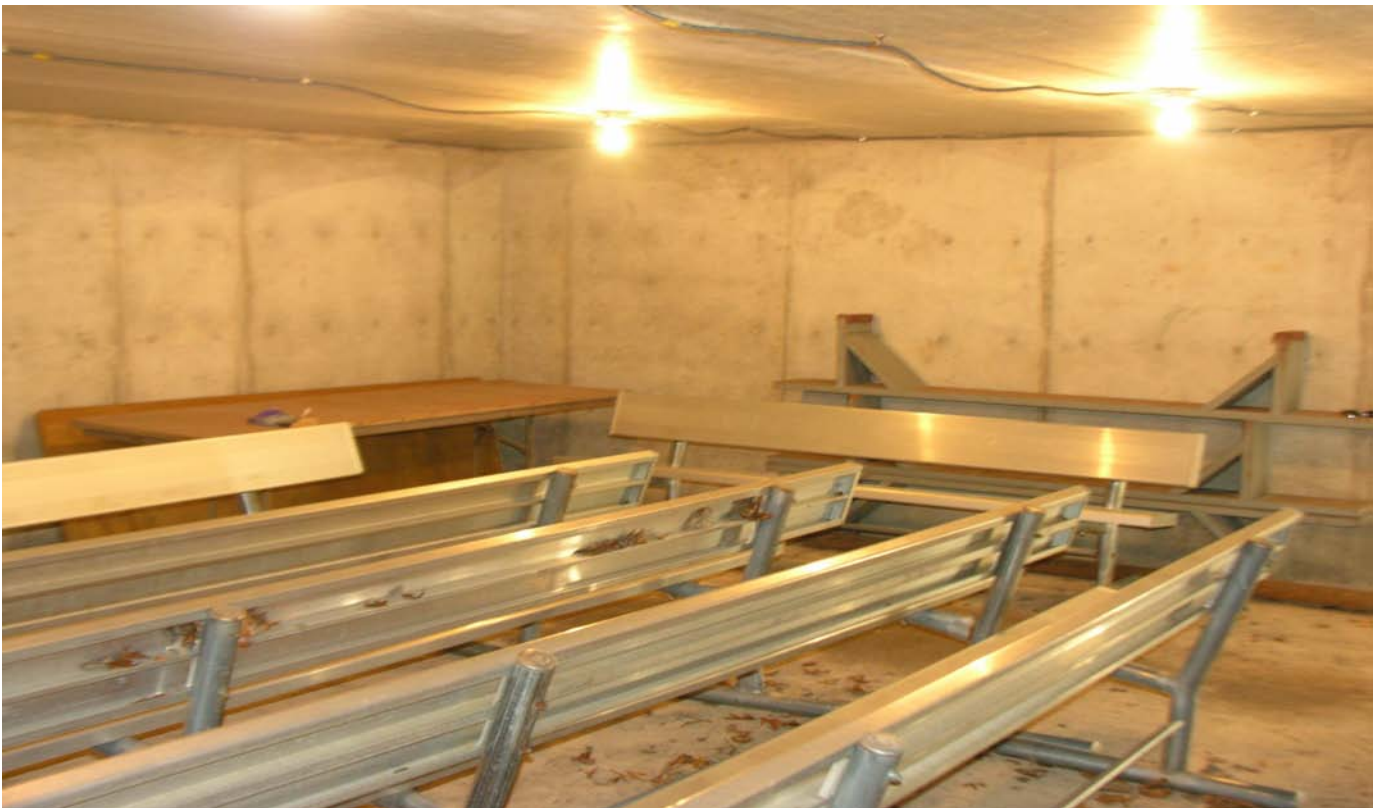
This is the inside of the current boys storm shelter. These are the benches from the campfire and they are stored in here. Otherwise, there are only wood benches to sit on. It has 4 lightbulbs in it. There is no bathroom.

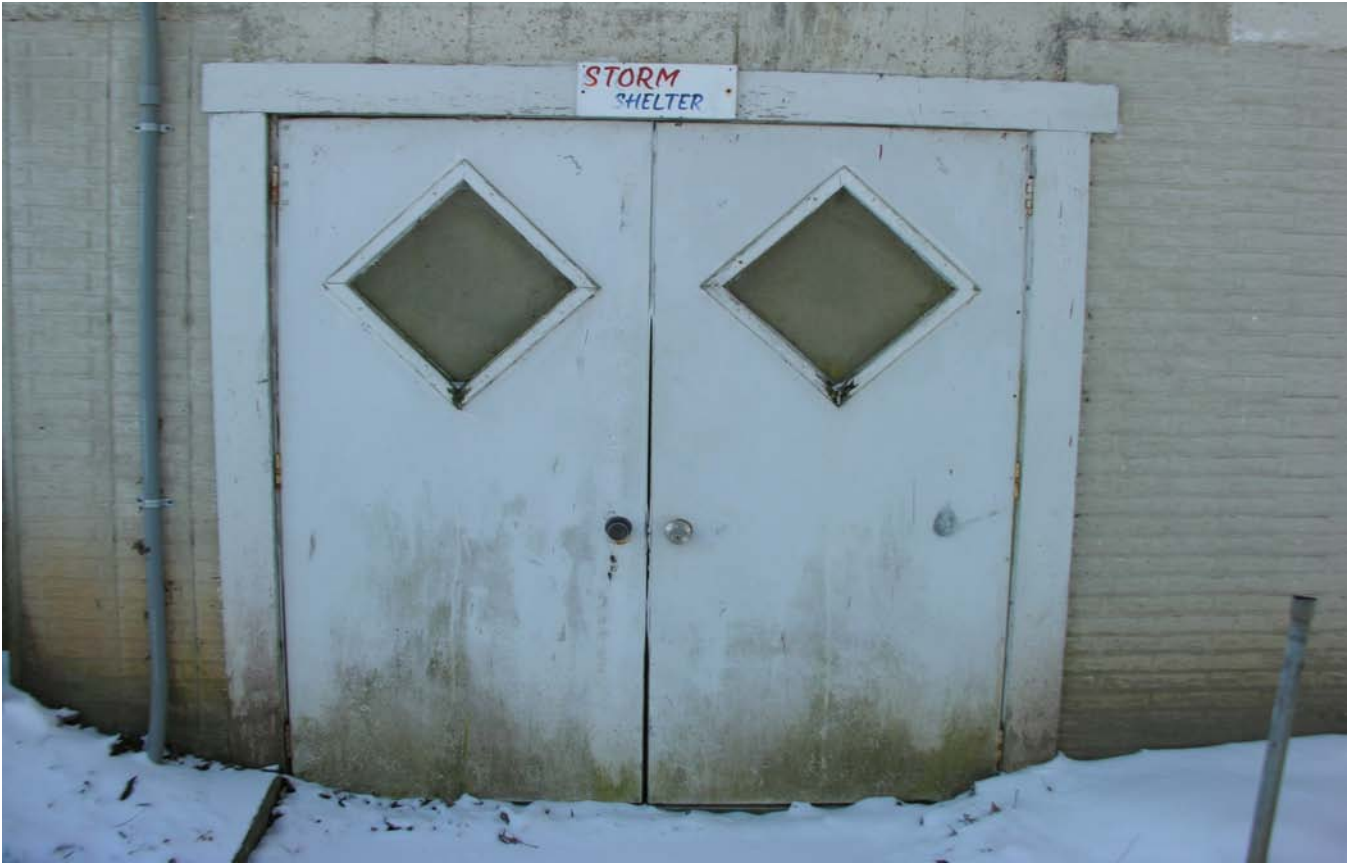
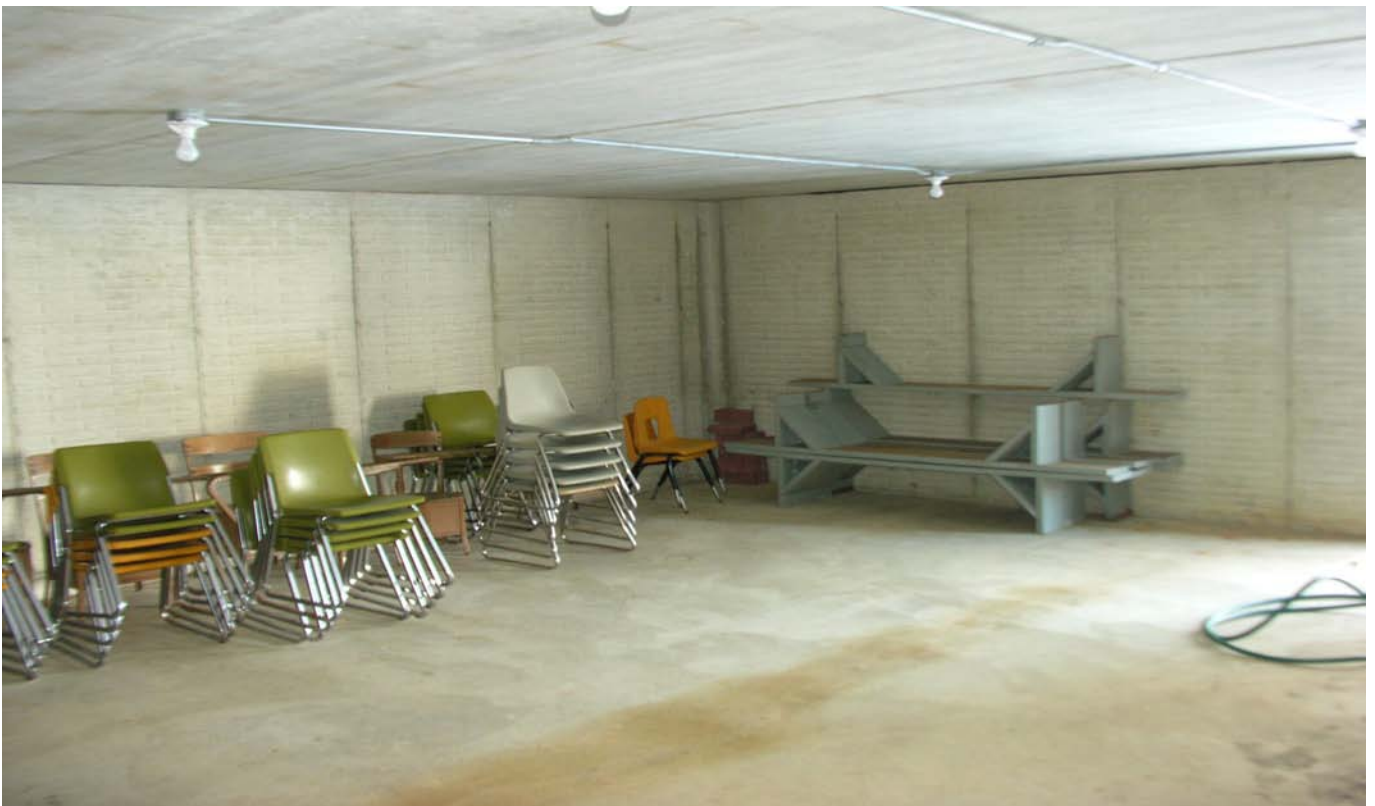
This is the current girls storm shelter. There are chairs and desks in here and it also has 4 lightbulbs for lighting. These are definitely emergency shelters only. Attempts have been made to use them as classrooms in the summer, but they are not conducive for that with the lighting and low ceilings. No bathroom.
